Waterboxx

This blog records an experiment undertaken by Sustainable Neighborhoods and CapMetro to use the Groasis Waterboxx to establish seedlings at nine North Central Austin bus stops.

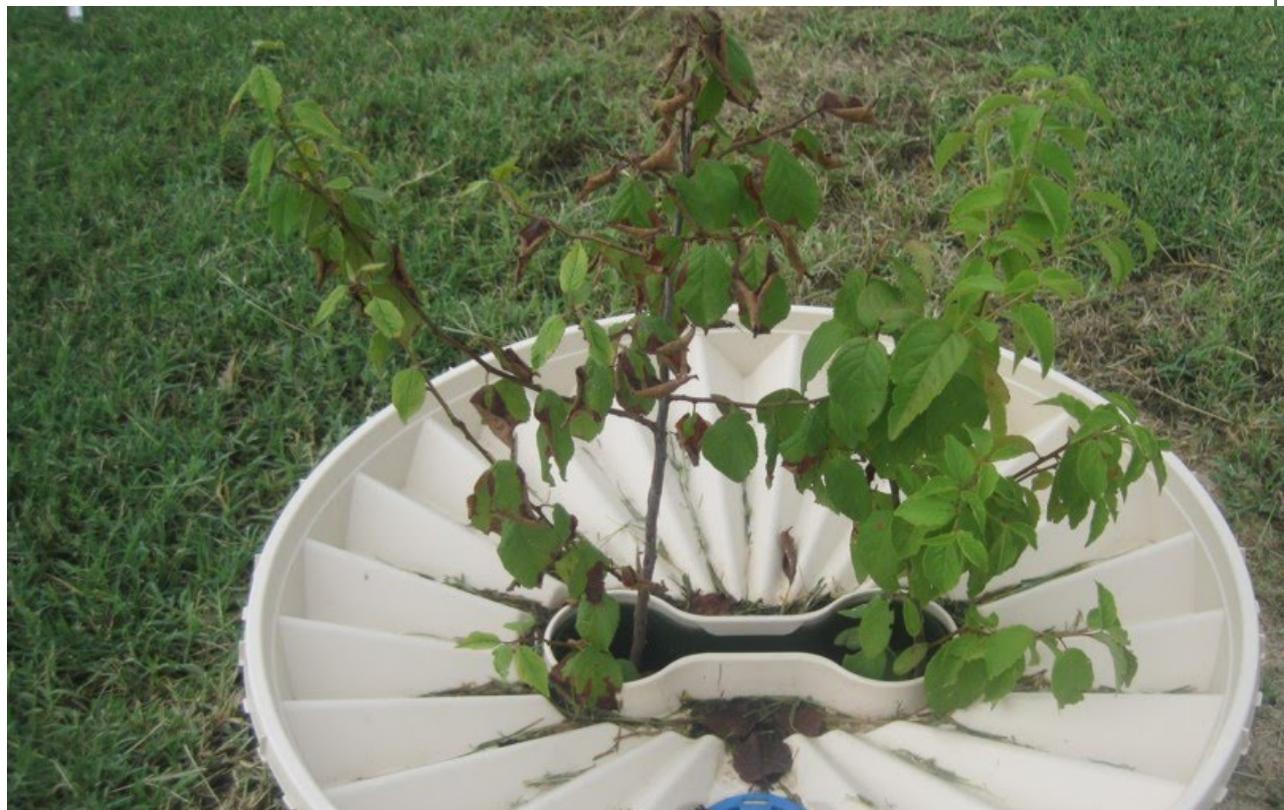
Here's a photo of a waterboxx at 6900 Burnet, where one of the plums is in poor shape, the other in good shape.

7/9/2012 - Visited several waterboxxes this afternoon. Several of the Mx Plums are in poor shape, with up to half brown leaves. One new dead plant at 8701 B. I think this is the result of a heat wave a few weeks ago. Weather the last week or so has been milder and just recently - more humid. But almost no rain yet.

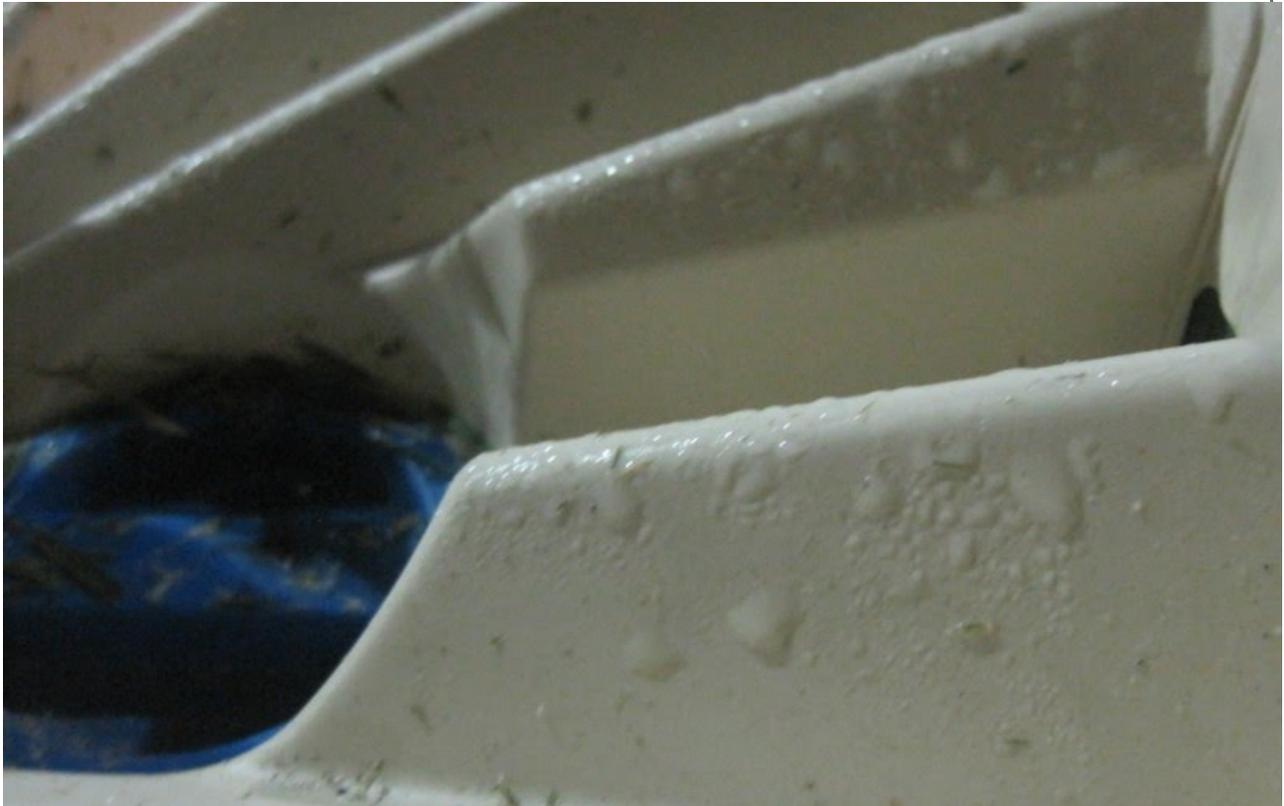
3/25/2012 - Woke up before 4 AM, and decided to walk down to see if the Waterboxx was in fact condensing water as promised. It was covered in water droplets. The temperature was about 59 F, from a high of 81 F the previous afternoon. Relative humidity at 4 AM was 93%, and dew point 57 F. Relative humidity of 93% is much higher than the Austin morning average for March of 79%. So we may be experiencing unusually good conditions for waterboxxes, if not for people.

This is consistent with most of the waterboxxes maintaining their water levels even several days after rainfall. But not all waterboxxes may condense water at a rate that compensates for the emission rate of the wick. Wondering if things like partial shade, wick length, or even ground moisture and temperature affect how quickly the tank will drain.

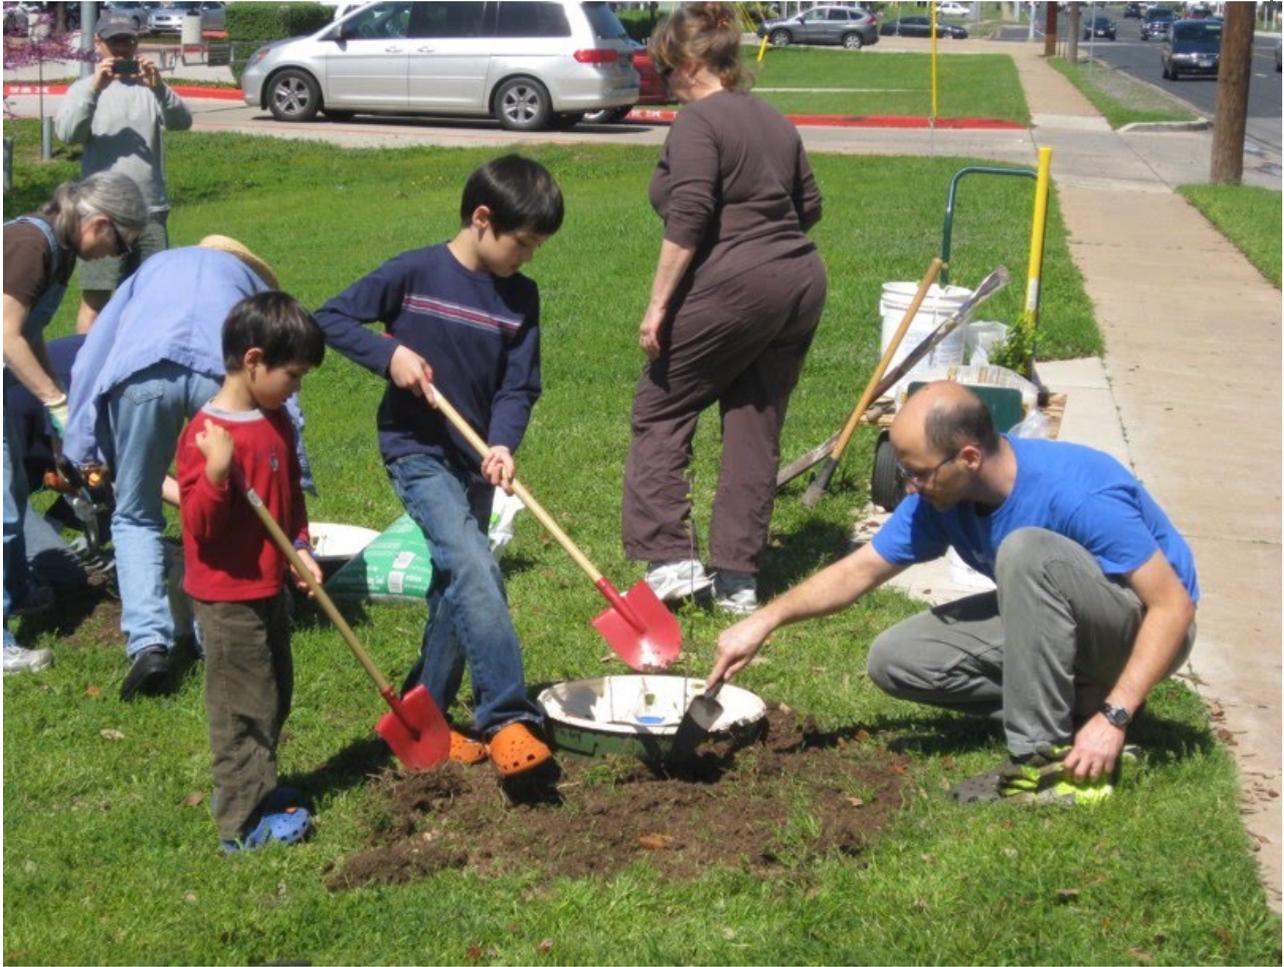
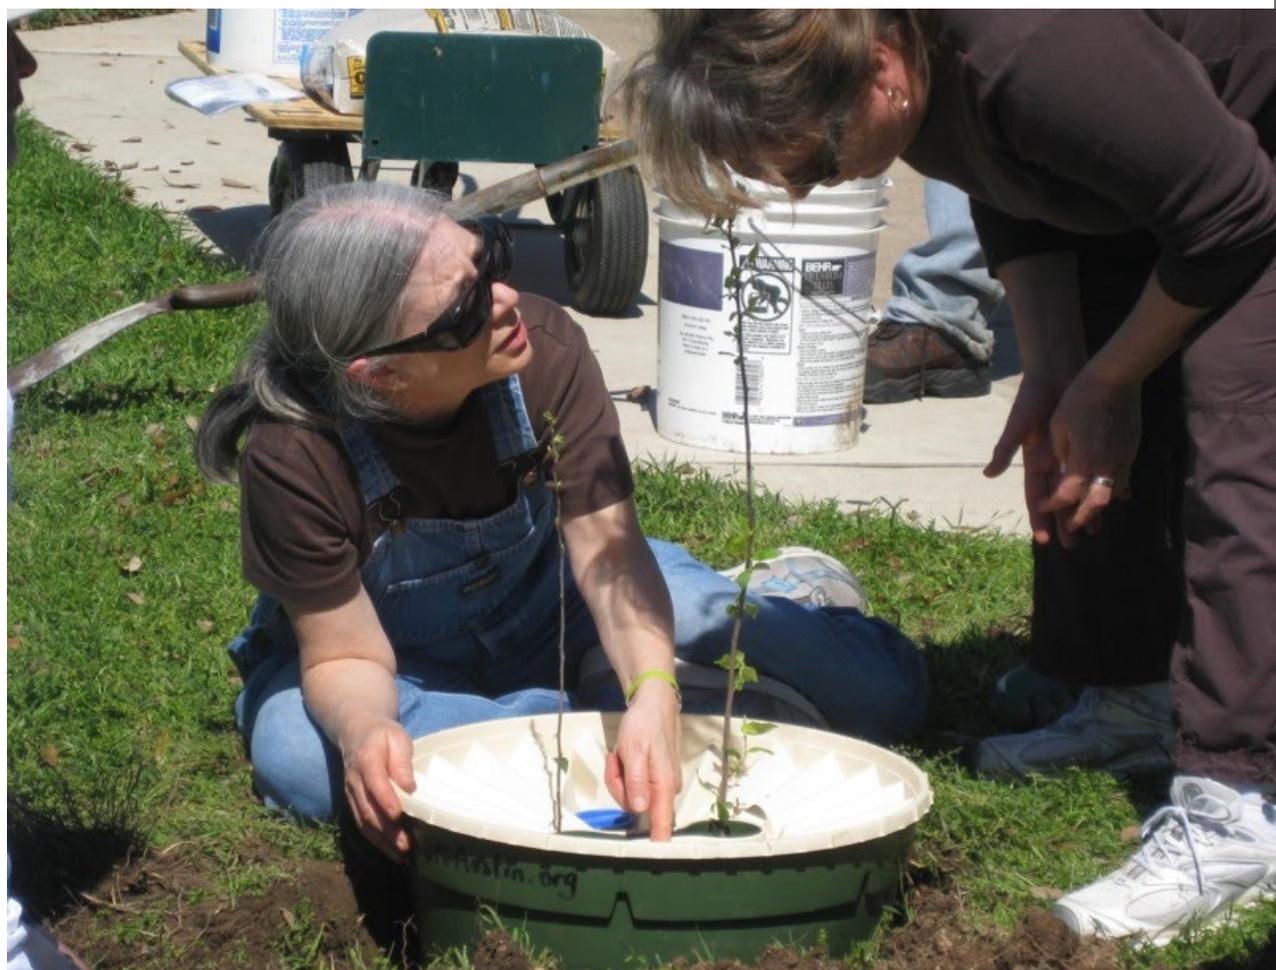
3/11/2012 - About 25 people from North Central Austin met at a bus stop to watch how to install the first Waterboxx, then broke up into teams to install the rest of them [at eight other stops](#).
